SCOTT'S RUN LAKE DAM

NDI - PA 00725
PA DER 6-435

PHASE I INSPECTION REPORT NATIONAL DAM INSPECTION PROGRAM

Name of Dam:	Scott's Run Dam ID #PA00725
State Located:	Pennsylvania
County Located:	Berks County
Stream:	Scott's Run
Coordinates:	Latitude 40° 12.5', Longitude 75° 47.7'
Date of Inspection:	May 2, 1979

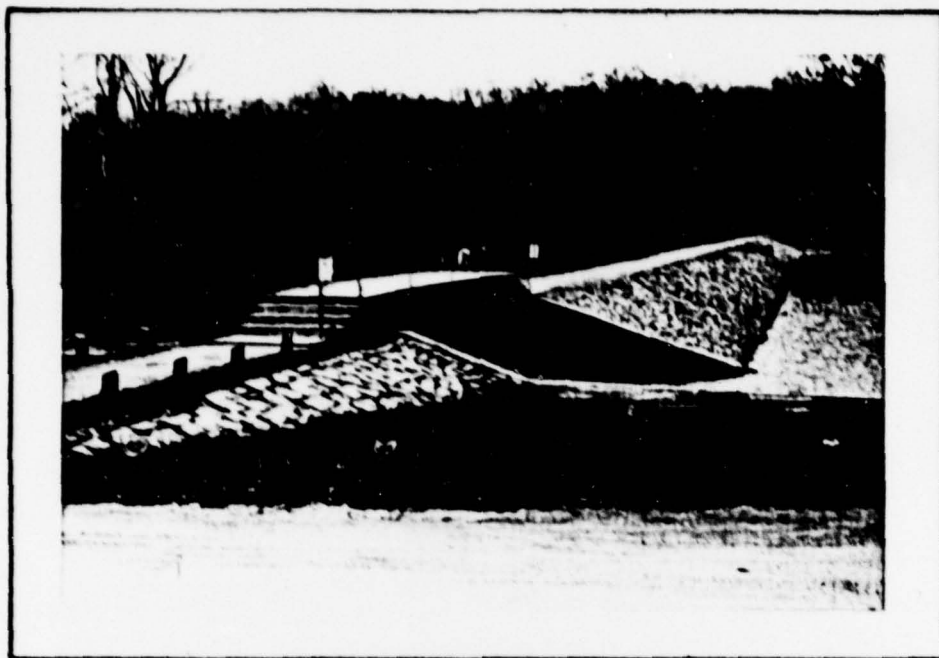
*UPSTREAM FACE OF THE DAM AS
VIEWED FROM THE LEFT ABUTMENT*

Several blocks of riprap on the upstream face have been displaced into the reservoir. These should be replaced to provide complete protection against wave erosion.

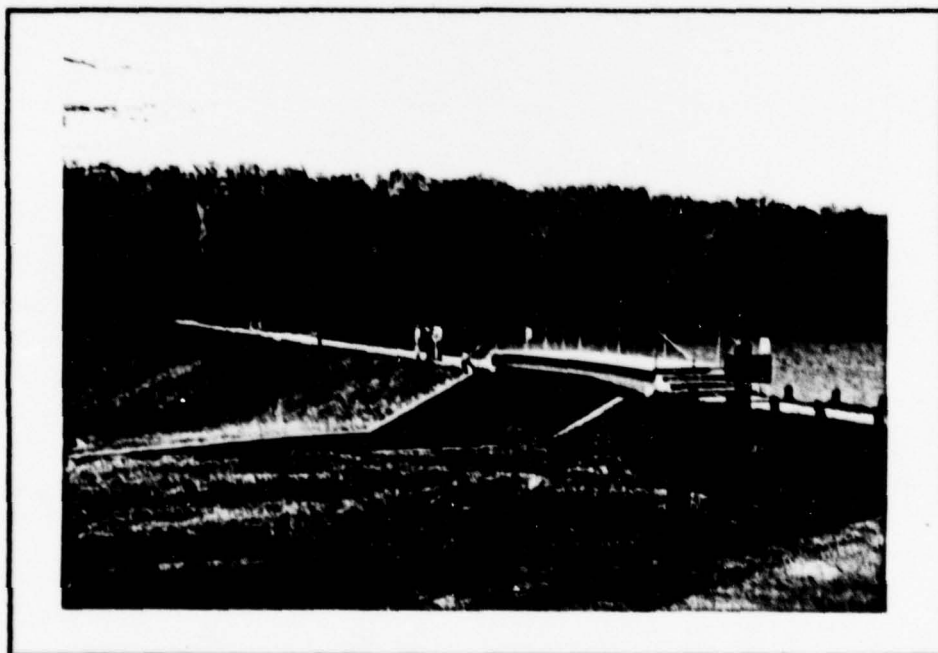
*DOWNSTREAM FACE OF THE DAM AS
VIEWED FROM THE LEFT ABUTMENT*

The downstream face of the embankment had a thick grass cover on the date of the inspection. Undulations of approximately six inches were apparent along the longitudinal axis of the downstream slope.

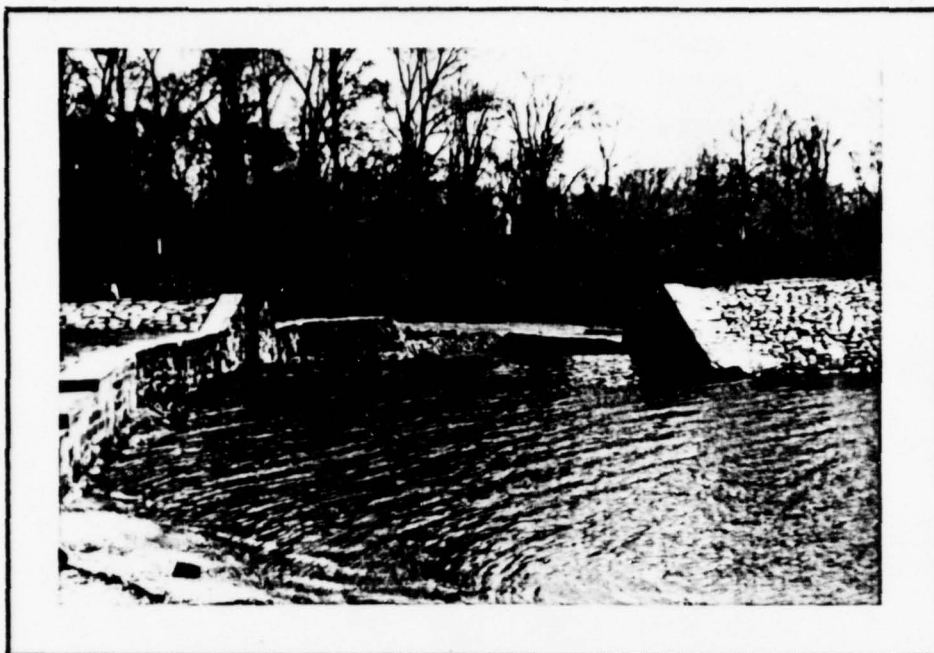
*SPILLWAY SECTION AND FOOT BRIDGE
LOOKING DOWNSTREAM*

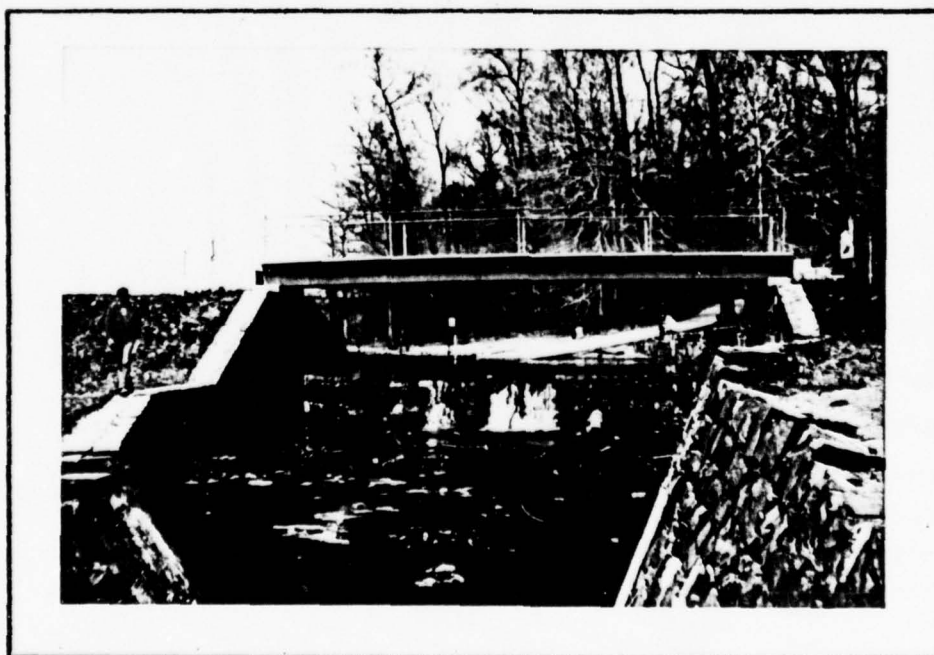
c. Appurtenant Structures. The crest of the masonry spillway is slightly deteriorated in that some of the stone has been cracked or chipped away. During the inspection, small quantities of water were flowing over sections of the spillway other than the normal discharge notch, even though the reservoir surface was approximately level with the spillway crest. The masonry training walls appear to be undamaged.

On the date of the inspection, the masonry spillway and training walls appeared to be in good structural condition and showed no signs of instability. The cracked portions of the spillway crest could lead to deterioration of the spillway structure if they are not repaired.

*SPILLWAY SECTION LOOKING UPSTREAM SHOWING
WATER FLOWING OVER THE LOW FLOW DISCHARGE
NOTCH AND LOWERED SECTIONS IN THE SPILLWAY CREST*

VISUAL EXAMINATION OF	OBSERVATIONS	REMARKS OR RECOMMENDATIONS
CONCRETE WEIR	THE MASONRY ALONG THE CREST IS SLIGHTLY DEGRADED.	REPAIRS TO MASONRY ARE RECOMMENDED TO RESTORE CREST TO DESIGN ELEVATION.
APPROACH CHANNEL	MASONRY TRIMMING WALLS EXPOSED A SHEAR CRACK ORIGINATING TO FORM AN APPROACH CHANNEL.	
DISCHARGE CHANNEL	THE SPILLWAY DISCHARGE CHANNEL IS LINED WITH GRAVEL RIPPED FOR ABOUT 60 FEET. TRENCH WITH HAND PLACED RIPRAP THE REMAINING DISTANCE TO THE STILLING BASIN.	
BRIDGE AND PIERS		NONE

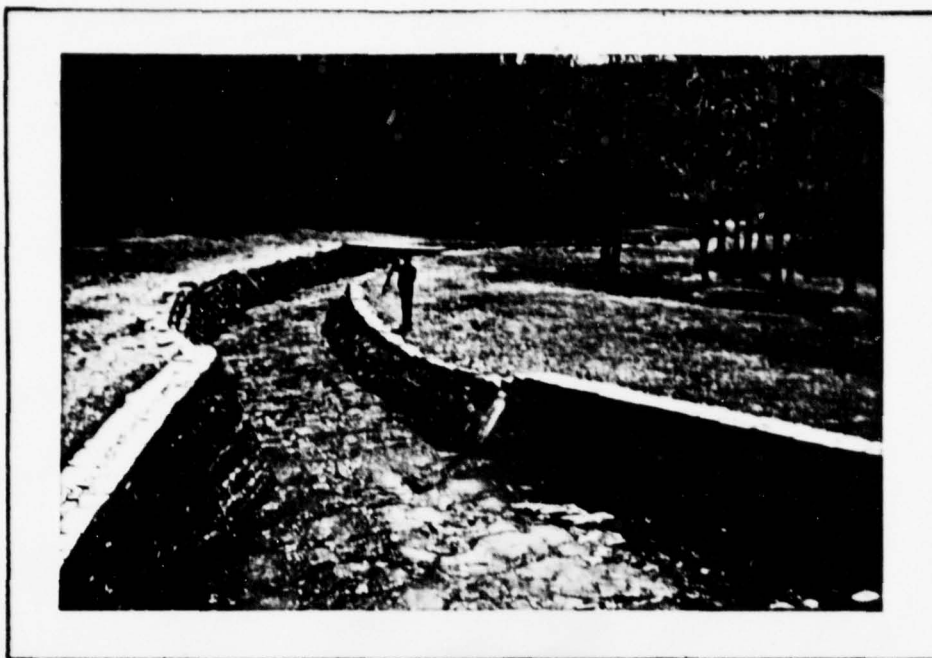
c. Visual Observations. The reduced discharge channel section downstream of the spillway does not appear to constrict the spillway flow due to the steep gradient of the channel and the available overflow area to the right of the channel. No other spillway discharge obstructions were observed on the date of the inspection (See Appendix C for computations).

*SPILLWAY DISCHARGE CHANNEL LOOKING DOWNSTREAM
FROM THE FOOT BRIDGE OVER THE SPILLWAY*

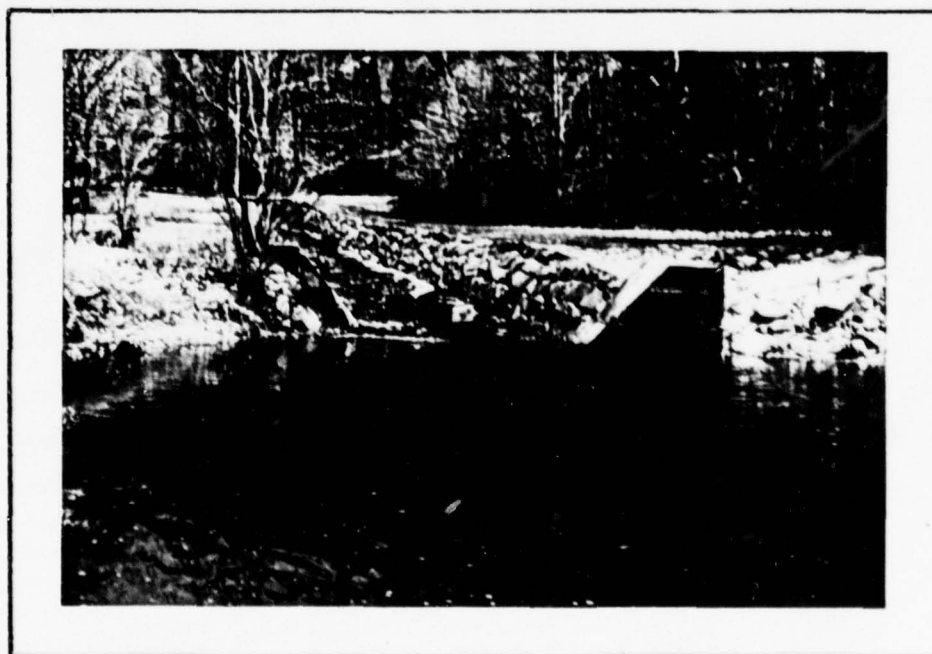
*STILLING BASIN AT THE DOWNSTREAM END
OF THE SPILLWAY DISCHARGE CHANNEL*

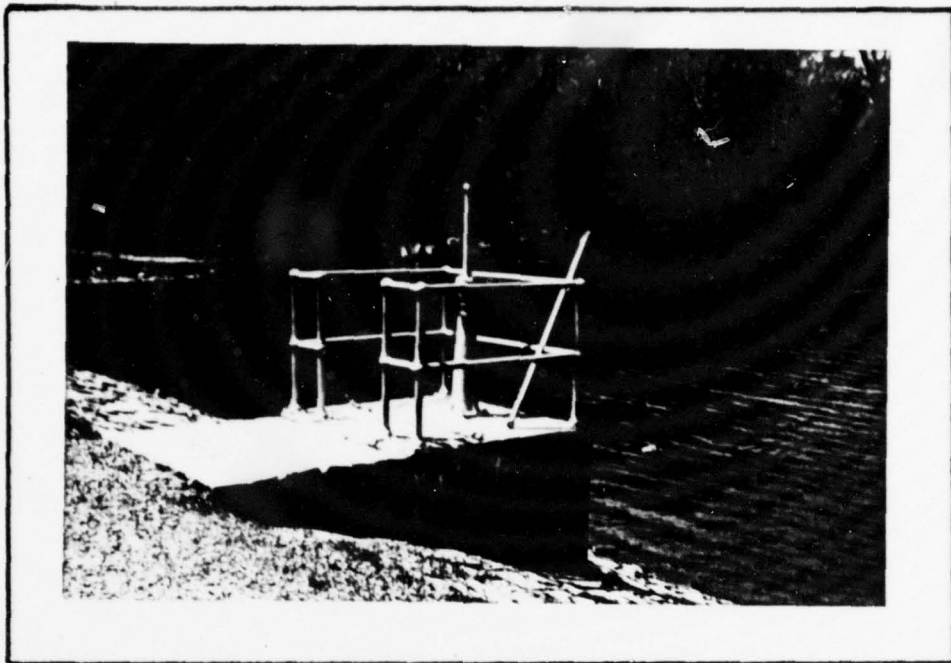
*GATE HOIST ON THE UPSTREAM FACE OF THE DAM FOR
THE RESERVOIR DRAIN OUTLET WORKS SLUICE GATE*
